Continued Study on Polyester Polymer Inlays on I-80

by Andre Totari – Senior Transportation Engineer, Caltrans

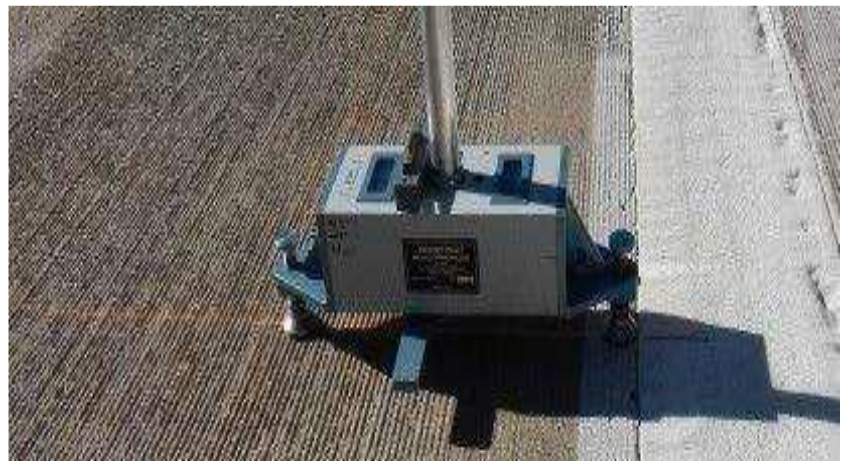
Figure 1. Transverse Profile Measurements using a Dipstick

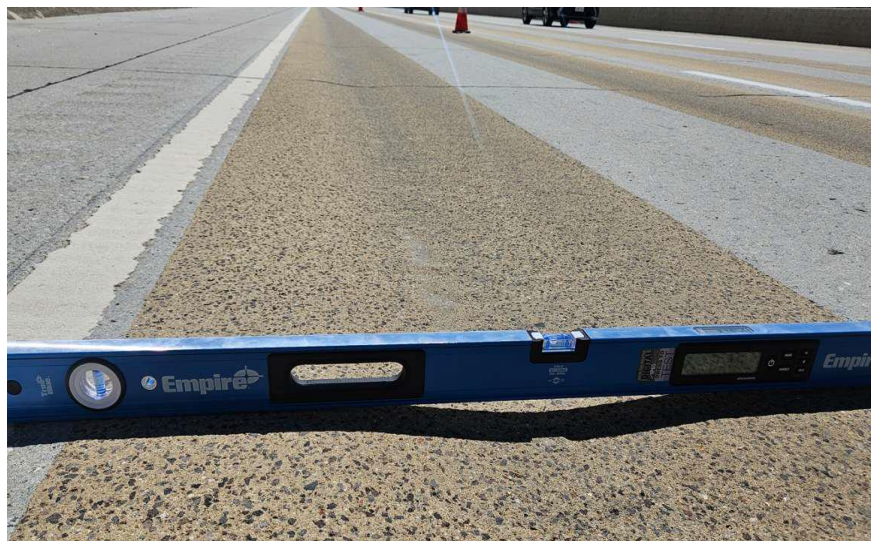
Figure 2. Wear Depth of Control Section

The control sections were constructed using standard polyester concrete (PPC) inlay materials in accordance with Caltrans 41-1.02C Standard Specifications. Over time, these sections showed progressive surface wear, with conditions significantly worsening by 2025. In several areas, the wear became severe enough to expose the underlying concrete pavement (Figure 2). Measured wear depths increased from less than 0.5 inches in 2024 to approximately 0.7–0.8 inches in 2025, indicating substantial material loss. Given that the original PPC inlay thickness was 0.75 inches, these measurements confirm that the polyester concrete layer has been completely worn away in some locations, leaving the older concrete pavement vulnerable to further deterioration.

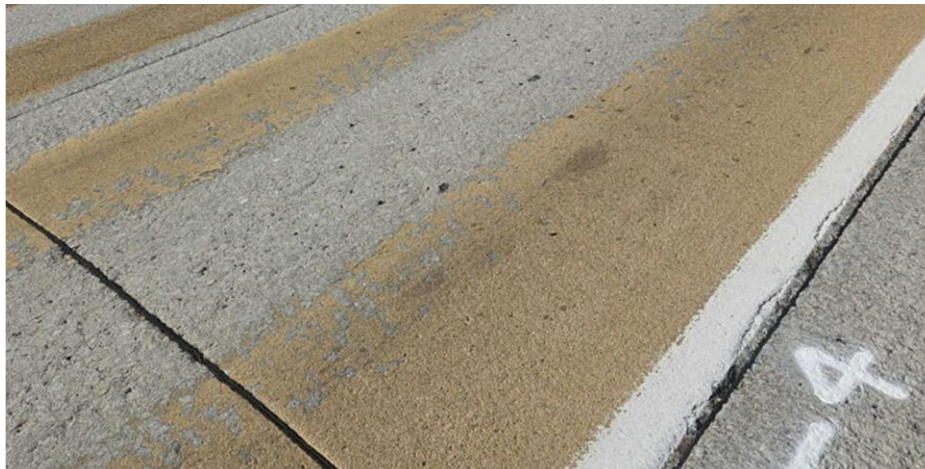
Figure 3. Experimental Bauxite Material with Underlying Concrete Visible

The bauxite experimental material was produced by combining an extremely hard bauxite aggregate with a conventional polyester polymer concrete (PPC) resin binder. This approach was based on the premise that the superior hardness of bauxite would improve resistance to chain-induced abrasion, while its smaller aggregate size would enhance bonding to the existing concrete surface, even in non-inlay sections where surface pre-grinding was omitted. Results from the second year of monitoring indicate that the material delivered moderate performance improvements compared to the control. However, it did not fully prevent deterioration. Certain sections exhibited advanced wear, including localized areas where the underlying concrete pavement became exposed (Figure 3). These findings suggest that while increased aggregate hardness contributes to improved durability, it may not be sufficient on its own to fully withstand the severe wear conditions present along this corridor.
