# Lessons Learned from the Construction and Initial Performance of a Double Chip Seal over a Paving Mat Pilot Project

DingXin Cheng \* and Lerosé Lane

California Pavement Preservation Center, California State University, Chico, CA 95929, USA;  
lerose.lane@gmail.com

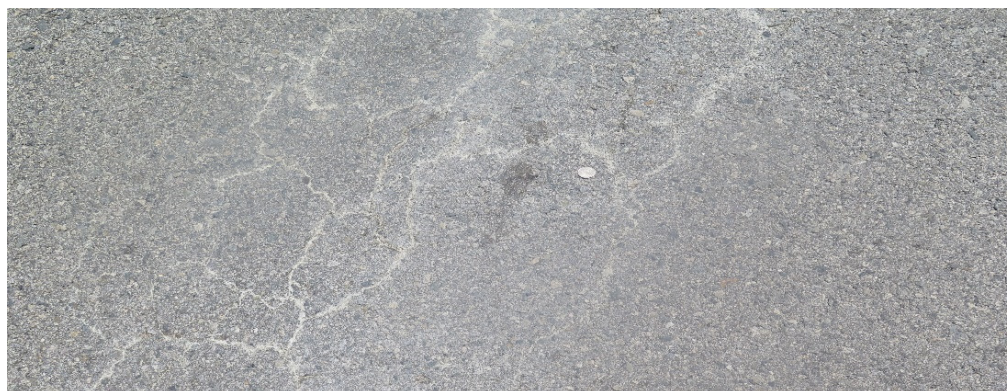
**Figure 2.** Alligator cracking. (a) Alligator B cracking on both left and right wheel paths, and pumping. (b) Example of pumping at wheel paths with fines in alligator cracking at test sections.

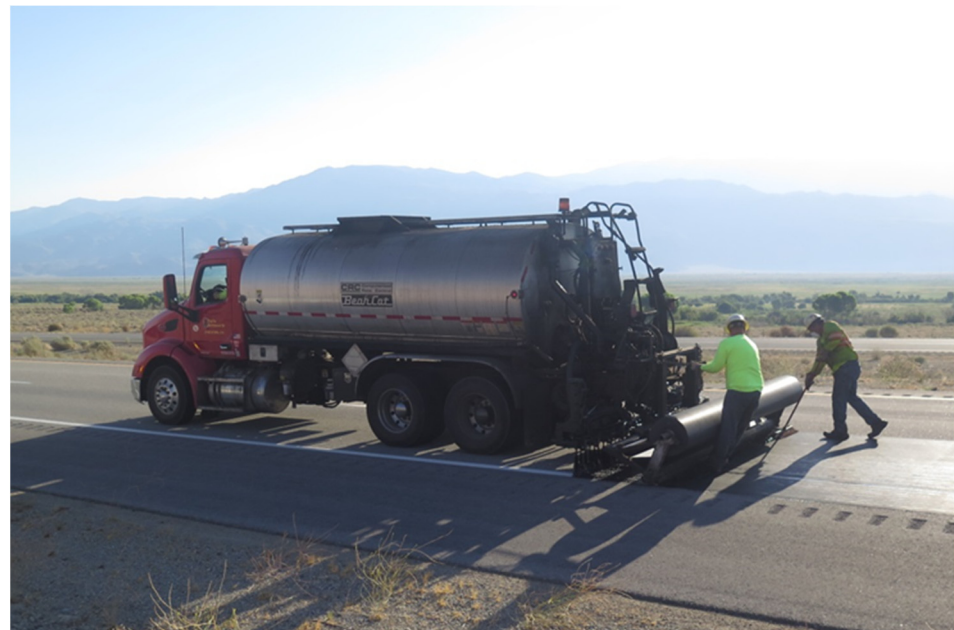
**Figure 3.** Distributor truck equipped with fabric bracket to apply PG 70-10 binder and paving mat or PRF.

- For the paving mat or fabric, the PG 70-10 binder was applied using a BearCat distributor truck also equipped with a bracket for unrolling the GlasPave 50 or PRF directly onto the pavement. The fabric or mat application process was performed simultaneously with the binder application, as shown in Figure 3. Within 10 s after the application, two rubber-tired rollers started working to remove the bubbles and smooth any wrinkles prior to applying the chip seals.

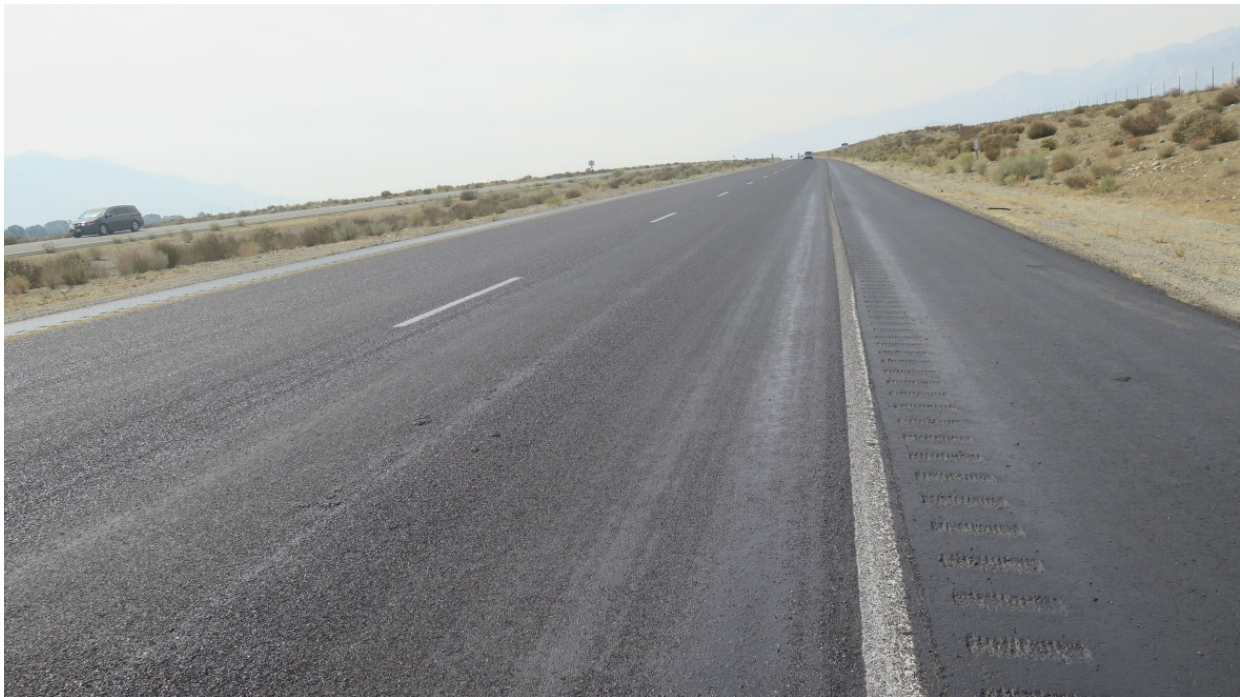
**Figure 4.** Treatment 2: PME bleeding in right wheel path at PES 4.

Treatments 1 and 4 were put down without significant problems during construction. Treatment 2, which included PESs 3 and 4, showed bleeding during the very hot afternoon after all of the southbound traffic was shifted to the No. 2 lane (truck lane) past the No. 2 lane edge stripe. This was when the temperature of the new double PME seal coat was measured to be 148 °F in the distressed right wheel path on the edge stripe. Figure 4 shows the bleeding of the double PME chip seal during the afternoon (one day after construction).

When the ambient temperature reached 105 °F, the PME had low viscosity, but it did not delaminate from the PRF.

The low viscosity problem in Treatments 2 and 3 was remedied by the contractor shifting traffic away from the edge stripe on the No. 2 lane and applying water to cool these PESs.

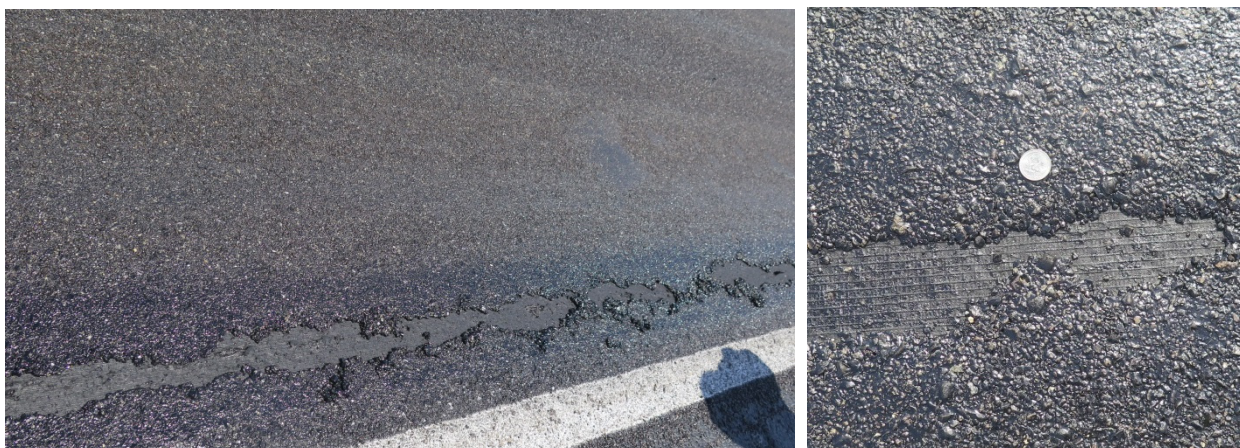
**Figure 5.** Treatment 3: delamination from GlasPave 50 and bleeding at PES 6.

Treatment 3, which included PESs 5 and 6, showed severe bleeding and some delamination in the very hot afternoon after all of the southbound traffic was shifted to the No. 2 lane past the edge stripe. Figure 5 shows the delamination of PME from the GlasPave 50 during the afternoon, when the ambient temperature reached 105 °F. This was one day after construction and the pavement temperature was close to 150 °F. The GlasPave 50 had a lower-strength bond with the partially cured asphalt emulsion, which caused delamination under active traffic.

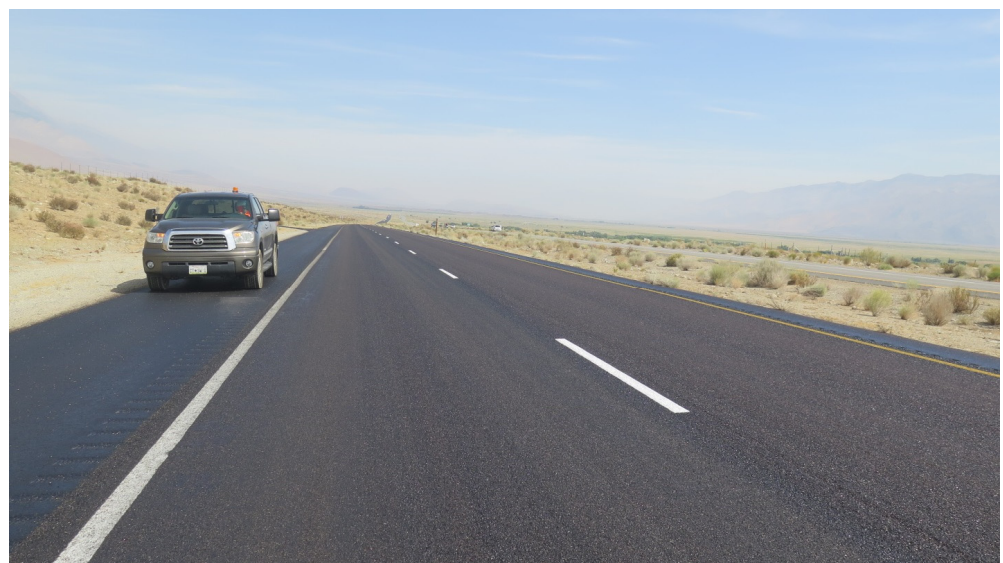
**Figure 6.** Looking north near south end of project on new double chip seal.

The overall finished double chip seal product looked uniform and smooth. Figure 6 shows the overall pavement condition, looking north from the south end of the project, while Figure 7 shows the overall double chip seal condition at each PES. Bleeding was visible for PES 5, and delamination near the right edge striping was shown in PES 6.

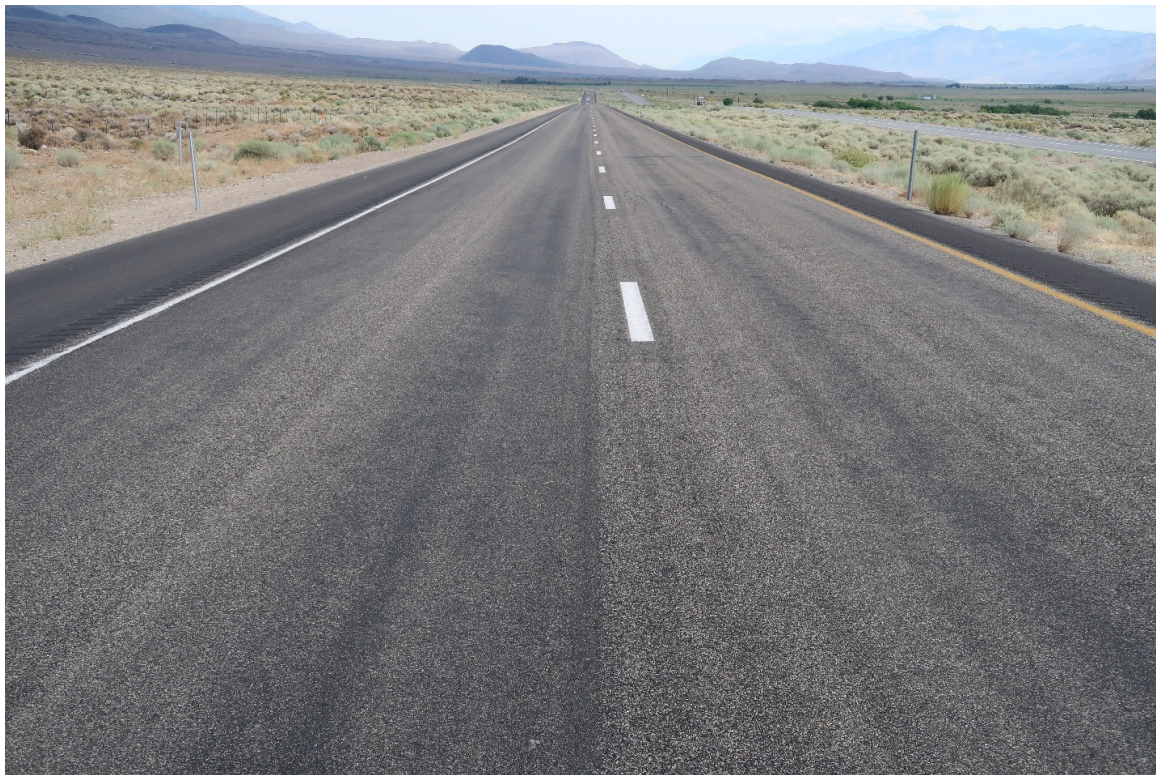
**Figure 8.** The surface texture of the double chip seals. (a) Overview of double chip seal over GlasPav 50 one year after construction; (b) Middle of a lane; (c) edge of the chip seal surface.

The double chip seal project was visited one year after the construction. Overall, as shown in Figure 8, there was no alligator cracking throughout the project, and the double chip seal with the GlasPav 50 paving mat prevented reflection of the fatigue cracking successfully for one year. Figure 8a shows the overall texture of the double chip seal surface.

In a chip seal lane, the surface was covered with 1/4-inch rock (Figure 8b), while at the edge of the chip seal (Figure 8c), some 3/8-inch rocks were visible.
